A POST HURRICANE IRENE RAPID BIOASSESSMENT OF THE WATER QUALITY OF THE SCHOHARIE CREEK AT BURTONSVILLE, NY

Mary Rachel Keville, Jacob Tanzman, Corrine Skala, Nick Marotta, Nick Lynch and John McKeeby
Schoharie River Center, Burtonsville, NY

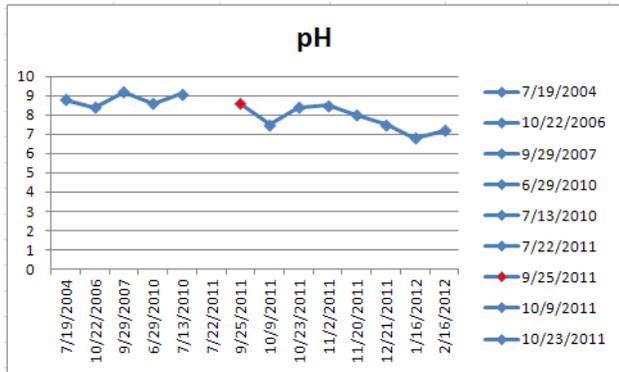
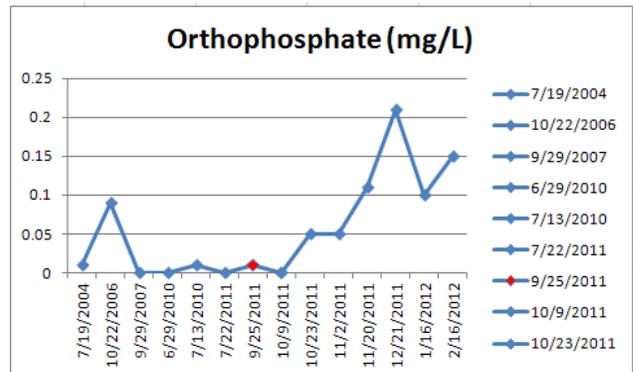
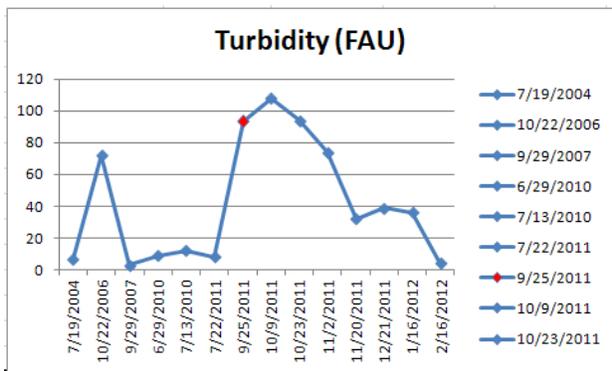
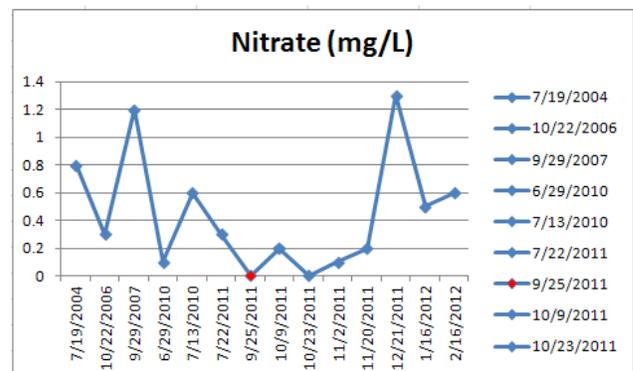
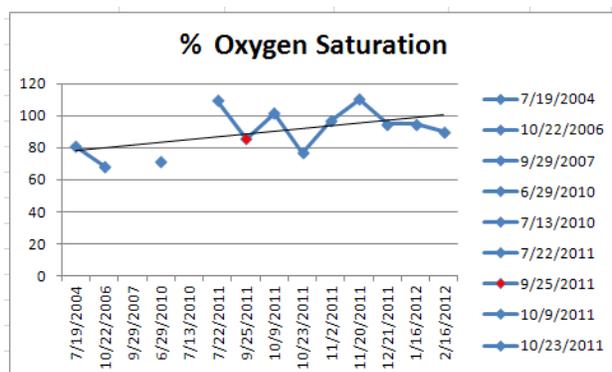
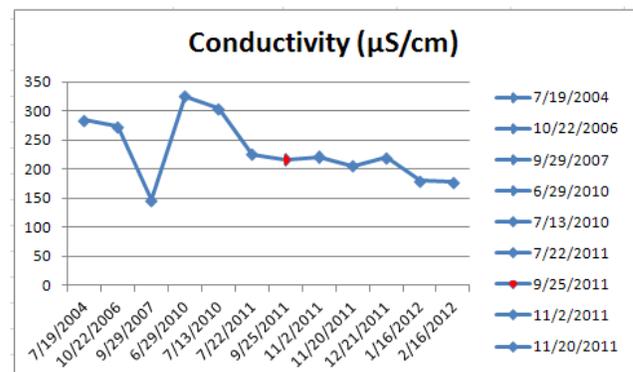
Schoharie Creek Water Chemistry Parameters

Red diamond indicates point in time after flooding caused by Hurricane Irene.

Date	7/19/ 2004	10/2 2/ 2006	9/29 / 2007	6/29 / 2010	7/13 / 2010	7/22 / 2011	9/25 / 2011	10/9/ 2011	10/23 / 2011	11/2 / 2011	11/20 / 2011	12/21 / 2011	1/16 / 2012	2/16/ 2012
Temp °C	24	9		18	28	30.3	22.1	17	13	9.5	8.6	5	2.5	6.5
pH	8.8	8.4	9.2	8.6	9.1		8.6	7.5	8.4	8.5	8	7.5	6.8	7.2
Alkalinity (mg/L)		100	62			73	85	118	84	92	61	88	30	52
Dissolved Oxygen (mg/L)	7	8	8.2	8.4		8.6	7.8	10	8.2	11.2	13	12.2	13	10.8
Percent Saturation	80.7	68.45		71.2		109.4	85.53	101.5 3	76.7	96.94	110.1 9	94.76	94.6 7	90
Nitrate (mg/L)	0.8	0.3	1.2	0.1	0.6	0.3	0	0.2	0	0.1	0.2	1.3	0.5	0.6
Orthophosphate (mg/L)	0.01	0.09	0	0	0.01	0	0.01	0	0.05	0.05	0.11	0.21	0.1	0.15
Conductivity (µS/cm)	284	273	147	325	304	225	215			220	205	220	180	178
Turbidity (FAU)	7	72	3	9	12	8	93	108	94	74	32	39	36	4
